## IMPORTANT PRODUCT RECALL NOTICE

Colt's Manufacturing Company LLC has determined that the **Slide Lock Safety** ("Safety") and/or the **Recoil Spring Guide Pad** ("Guide Pad") in certain Colt model pistols were not manufactured to Colt specifications and **must be replaced**. All of these Colt models were sold after March 2007 and the range of serial numbers affected by this product recall is as follows:

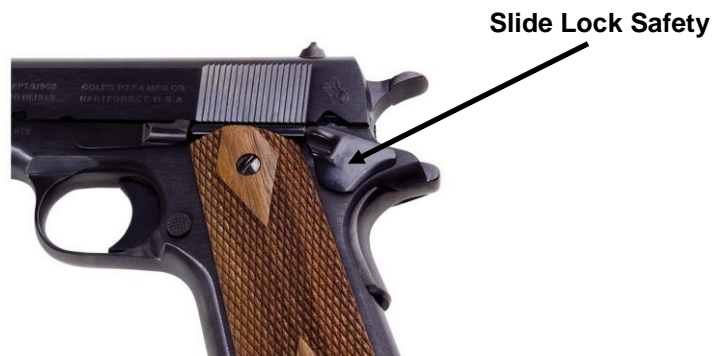
The Safety is located on the left side of the pistol just below the slide:

Colt has determined that the Safety and the Guide Pad in the affected pistols are of improper hardness. As a result, the Safety can prematurely wear or bend, especially if the pistol is dropped, possibly rendering the Safety incapable of preventing an accidental firing, and the Guide Pad might crack and possibly prevent the pistol from firing. Although there have been no reports of personal injuries or property damage, safety is our number one concern. Therefore, the affected pistols should not be loaded or used until the Safety and/or Guide Pad have been replaced.

3. We will replace the Safety (and, on NEW AGENT models only, install a new Recoil Spring Assembly Kit that includes replacement of the Outer Recoil Spring and Guide Pad) and return your firearm to you as quickly as possible.

5. **DO NOT ATTEMPT TO MAKE THIS REPAIR YOURSELF.** The Slide Lock Safety **must** be replaced at the factory in order to be done properly.

For **1911 WWI REPLICA, 1918 WWI REPLICA, and COMBAT ELITE** models on which the Slide Lock Safety has been replaced, our gunsmiths will stamp a small “-“ on the inside right rear of the slide, directly below the extractor, as confirmation that the retrofit has been performed. **NEW AGENT** models on which both the Slide Lock Safety and Recoil Spring Guide Pad have been replaced will have two marks. Our gunsmiths will stamp a small pennant “F” on the top right side of the trigger guard as confirmation that the Slide Lock Safety retrofit had been performed. The new Recoil Spring Guide Pad has a small dimple appearing on the top left, rear-facing, surface of the pad.

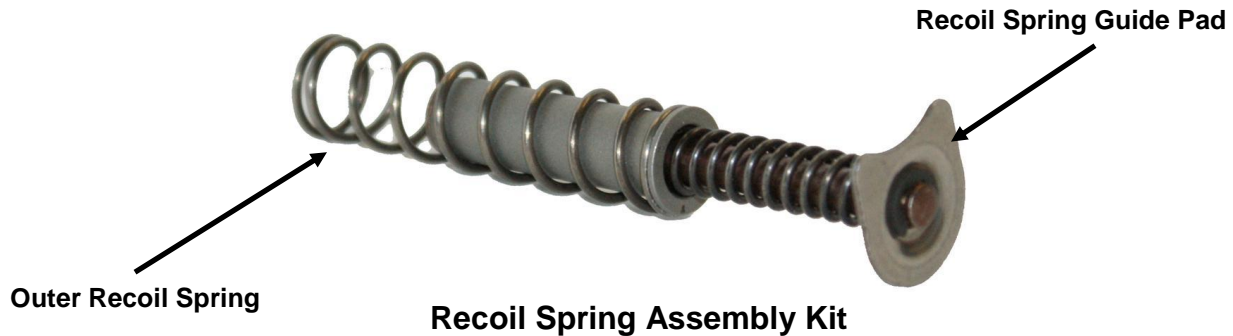
The Guide Pad is located at the end of a recoil spring assembly, which is positioned inside the slide between the recoil spring bushing and the barrel lug. On the recoil spring assembly, the Guide Pad looks like this:

Please note that, apart from this recall, we designed a symmetrical Outer Recoil Spring with closed ends on each side for the NEW AGENT and DEFENDER models. This design allows the spring to be inserted from either end into the recoil bushing. This replacement spring will be included as part of the Recoil Spring Assembly Kit being furnished in this recall. The new Recoil Spring Guide Pad has a small dimple appearing on the top left, rear facing, surface of the pad that will serve as confirmation that the retrofit has been performed.
